Annual project July 2017 – June 2018

Conservation of Swiss Molasses

Stiftung zur Förderung der Denkmalpflege

May 2019

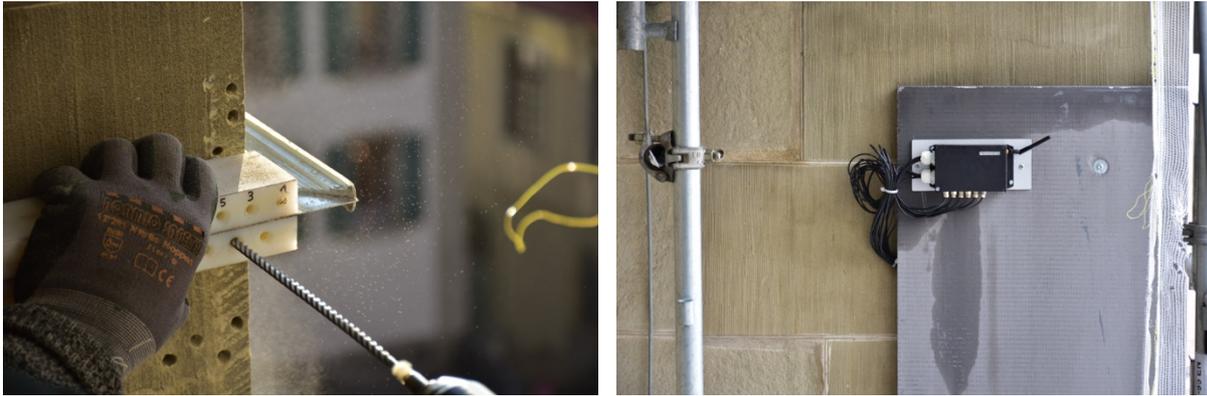
Figure 5 - Drilling operation and completed installation of Smartmote at the Cathedral of Lausanne. South transept.

T and RH sensors were protected against liquid water by a porous teflon layer, then simply inserted at the chosen depths. Impedance sensors require more attention when embedded, as a continuous, conductive contact must be ensured between the electrodes and the stone. For this, we used a conductive silicon (EMI/RFI Conductive adhesive ref: SS-25-1) provided by Silicone Solutions (Cuyahoga Falls, OH, USA). An insulating polyurethane foam board was then installed over the perforations, to ensure no interference from the open side to the measuring sensors (Figure 5).

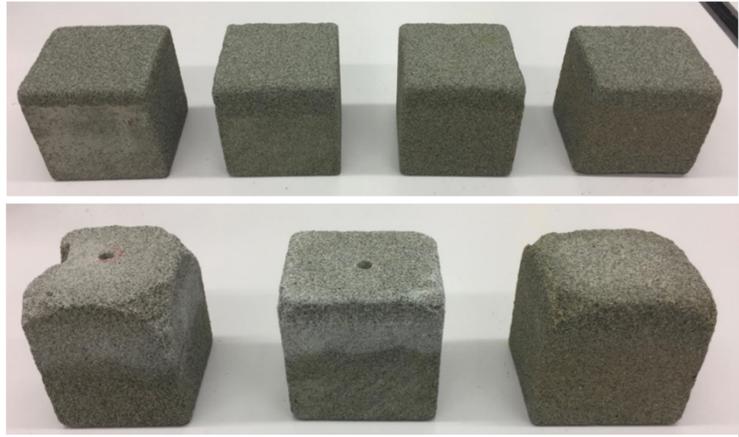
Figure 7 - Villarlod molasse cubes, subjected to various artificial weathering protocols by acid attack with hydrochloric acid (top) and sulfuric acid (bottom)

Based on the limited literature on pre-aging of sandstones with a carbonate matrix, a controlled acid attack was selected as the most suitable method. The intended mechanism is to degrade the samples with diluted acid solutions to partially dissolve the carbonate cement of the stone, inducing granular disintegration and increasing porosity. Two categories of samples were produced; non-contaminated samples for studies on consolidation and swelling inhibition, and salt-contaminated samples that can be used to study the susceptibility of a consolidation treatment to contaminations found on historic monuments (Figure 7). Hydrochloric acid (1.4-5.6M) was used to obtain non-contaminated samples, as most chlorides are highly soluble and may be extracted by desalination. Sulfuric acid (0.6-1.4M) was used to obtain sulfate-contaminated samples, as sulfates are abundant on the façade of the cathedral of Lausanne [17].

The degradation was characterized by mass loss, Ultrasonic Pulse Velocity Measurements (UPVM), Scanning Electron Microscopy-Energy Dispersive X-Ray (SEM-EDX), lateral dilatation swelling tests, and mechanical testing with a mini three-point bending test setup (TPBT). The artificial degradation was compared to naturally degraded stone in situ at the Cathedral of Lausanne by a Drilling Resistance Measurement System (DRMS) (Figure 8). It was found that a repeated impregnation by sorptivity with a 0.7M solution of sulfuric acid was ideal to reproduce conditions observed on-site, and possibly tune the desired depth of degradation. A salt contamination with Calcium and Magnesium sulfates localized within the first 4 mm of depth of the degradation was also obtained. Such results are perfectly compatible with known measurements of sulfate contamination on facades of Swiss buildings of historical interest [17].
